# Research into the Safety of London Bus Passengers

**Final Report**

**Transport Safety Research Centre  
Loughborough Design School  
Loughborough University**

**This research was carried out by Loughborough University for and on behalf of London  
TravelWatch**

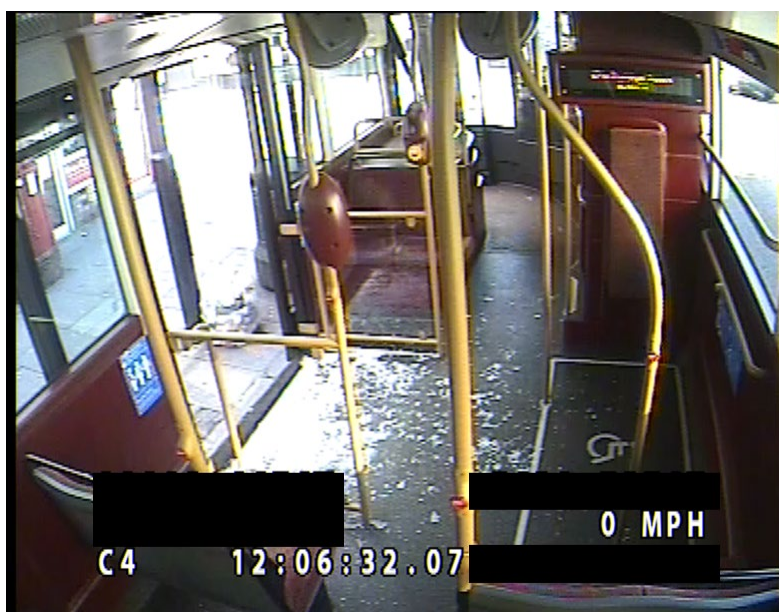
Figure 5: Example of the forward-facing seats into the wheelchair area

A number of the incidents analysed showed passengers sat in the seats facing forward into the buggy / wheelchair area (Figure 5).

They appear to be the seat of choice for many passengers with or without pushchairs or shopping trolleys; obviously the reason for this cannot be determined from the CCTV, but the passengers might view this as a convenient seat to alight the bus or is simply more spacious. Sometimes these are the first accessible seats after boarding dependent on the bus designs as some have an inaccessible high step up to the seats to the nearside of the bus immediately after boarding. Some passengers with shopping trolleys will hold onto these and not to handrails for support (Figure 6) whereas those boarding with a pushchair park them and do not hold on to them all of the time if they are sat in the seat.

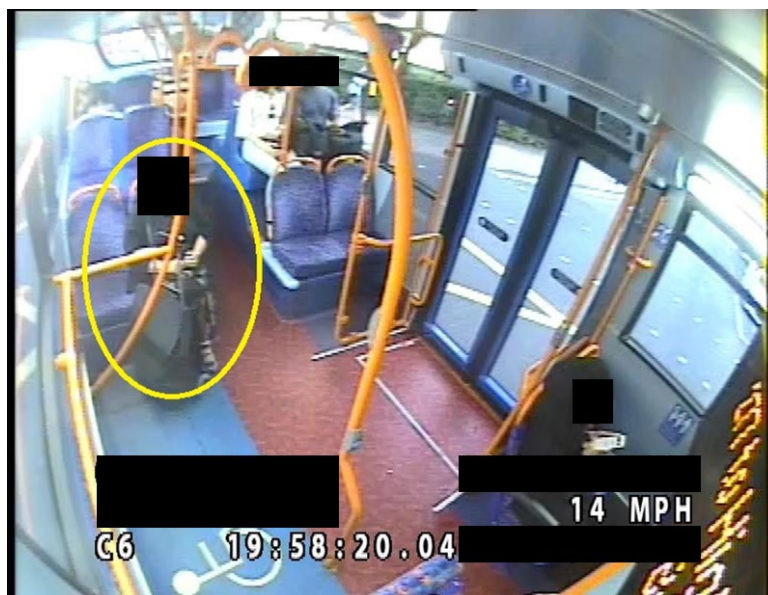
Figure 6: Passenger seated with shopping trolley in forward facing seats into wheelchair area

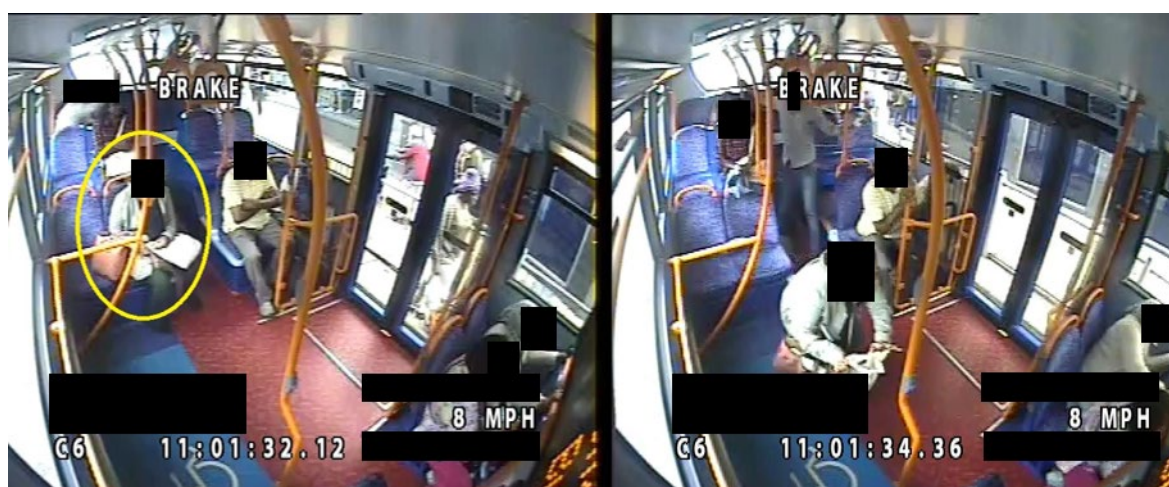
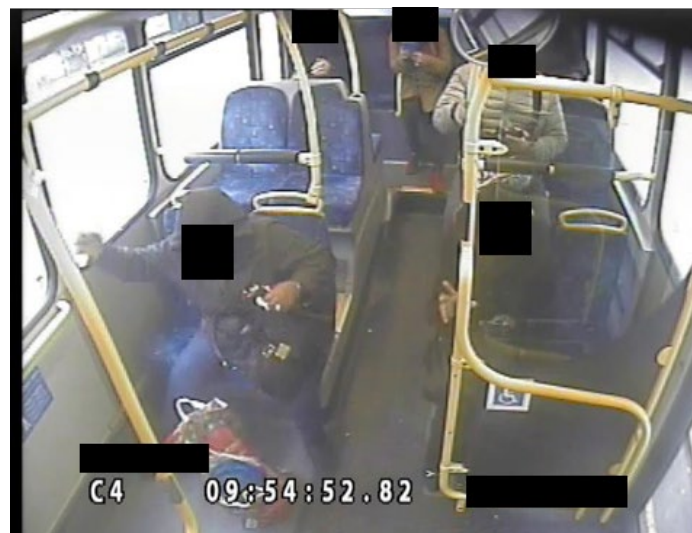
Notably the horizontal handrails in front of these seats were varied in style and shape which either contained the passenger in the area when thrown forward or enabled the passengers to be thrown out of the seats into the buggy / wheelchair areas (Figure 7). One of the incidents involved a point of failure when the glass panel immediately in front of the seats shattered as the passenger was thrown forward (Figure 5) and a different design of handrail. The perception of these seats in the analysis is that they are potentially unsafe as passengers are thrown out of them onto the floor and some appeared to travel some distance before landing due to the lack of full handrail or panel. Rear seats were also considered to be problematic as passengers do not have something to hold onto when sat in the middle of the rear aisle causing them to be thrown forwards down the aisle.

Figure 7a: Example of passengers thrown forward and variation in handrail design

Figure 7b: Example of passengers thrown forward and variation in handrail design

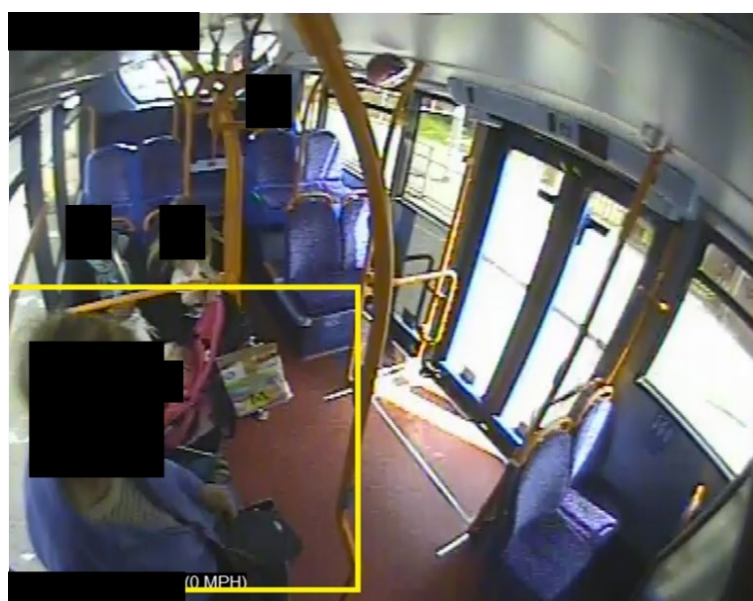
From the CCTV, passengers were either forced to stand because of lack of seats or they chose to stand during the journey. The choice to stand appeared to relate to having a pushchair on board and the passenger stood with this in the buggy area. However other passengers chose to stand in this area despite free seats being available possibly because they had a shopping trolley, or in one instance a guide dog (Figure 8).

Figure 8: Passenger choosing to stand in wheelchair area with shopping trolley

Unfortunately, in cases of harsh braking, the passengers were thrown forward or fall to the floor as often they were leaning on the infrastructures and not holding onto any handrail or pole for support.

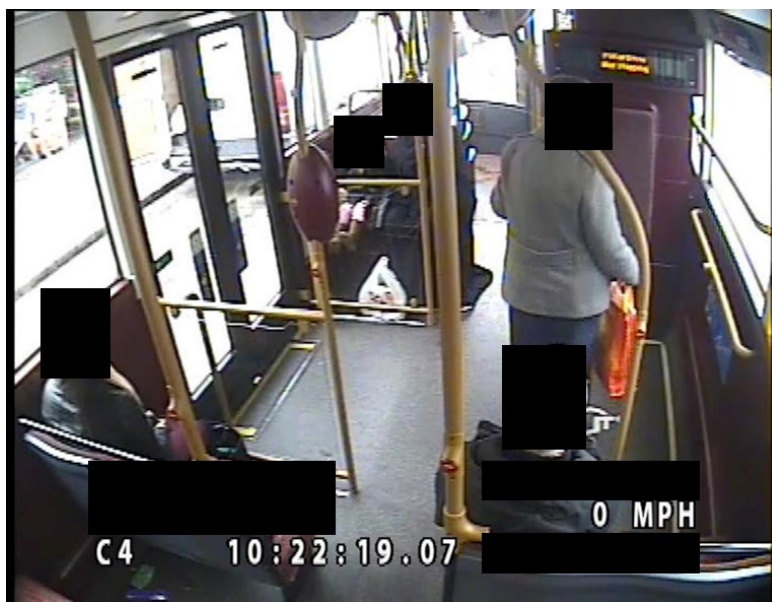
Obviously holding on whilst standing is not always going to be sufficient support to prevent passengers falling or being thrown around as the extent and aggressivity of braking determines the inertial forces on the passengers. This was evident in some incidents where people were standing during the journey and subsequently fell; however there is a problem of passengers standing in preparation to alight the bus who then fall or are thrown around (Figure 9).

Figure 9: Passenger choosing to stand early to alight bus and hold onto pole

In these incidents, the passenger’s choice to stand is questioned as they could remain seated until the bus has pulled into the stop. However, it was evident that passengers tend to stand early to alight, but the reasoning behind this is not determinable from the CCTV. Those passengers alighting the bus from upstairs also tend to move early which suggests that not missing their stop is of prime concern - they fear that if they are not at the doors in time the driver will pull away. Whether the driver can see passengers on the stairs is difficult to establish from the CCTV, but it is assumed that this is not the case. The visibility of passengers on the stairs is then an issue for the driver if they are unaware of alighting passengers that could potentiate a “late” alighting incident involving the closing doors.

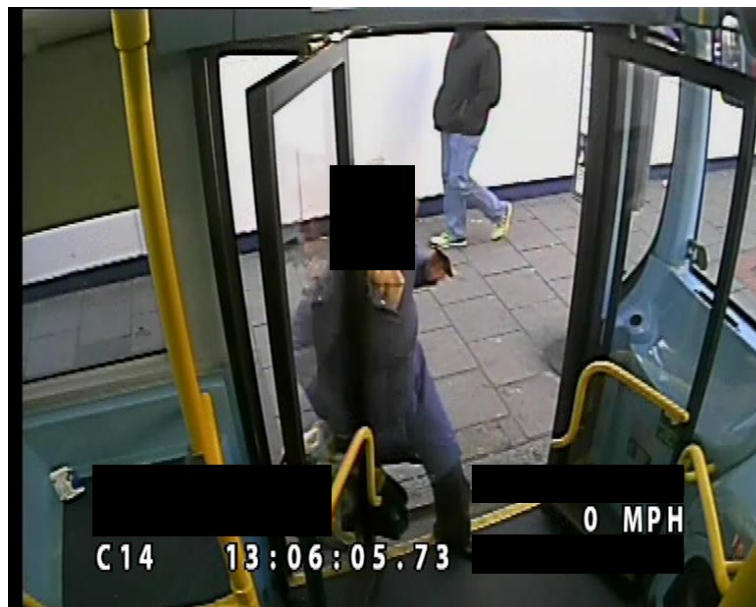
Drivers control the doors but there is an issue with doors closing on passengers and this can either be the fault of the driver or the passenger (Figure 10). What is evident is that once the doors are in the closing operation, they do not stop even if there is a person in the way and therefore it is assumed that sensors are not embedded in the doors. Furthermore, the view for the driver appears to be hampered in a crowded bus - particularly regarding alighting passengers from the rear doors and passengers descending the stairs. It appears there is a potential blind spot for the drivers if passengers' approach along the length of the nearside of the bus to board at the front doors.

Figure 10: Passenger boarding with closing doors

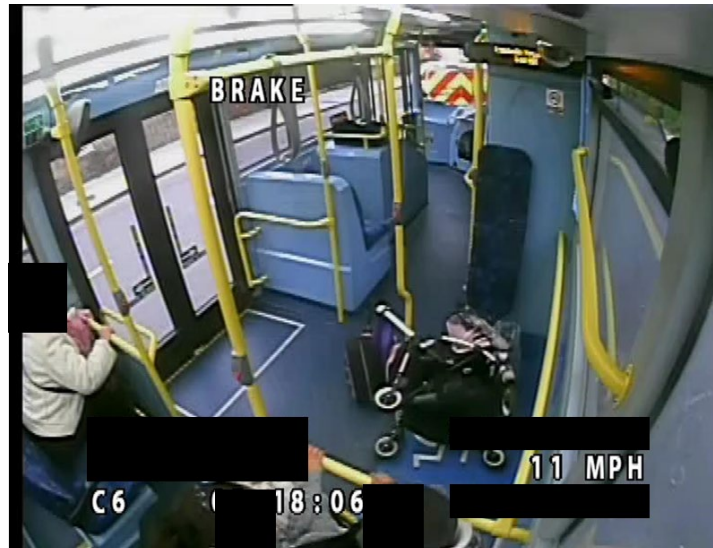
Parking of pushchairs is of interest and in cases where numbers of pushchairs are parked at 90° across the bus they appeared more stable compared to single pushchairs parked at 90° or 45° angles (Figure 13). It is noted though that some pushchairs do appear to have their handles loaded with shopping or 'nappy changing bags'.

Figure 13: Pushchair tipping over sideways

One incident involved a mobility scooter parked at 90° which toppled over - passengers helped to upright the passenger and scooter and the passenger then manoeuvred into a parallel position running along the offside of the bus.

The positioning of both pushchairs and wheelchairs is interesting as there are no markings on the floor to assist passengers to make the best decisions of how to park.
